# Manhole Inspection Summary

Manhole # S31GG2014MH

Insp Date: **12/21/06 10:29 AM**

**Location** Address: **101 FIRESIDE CIR**

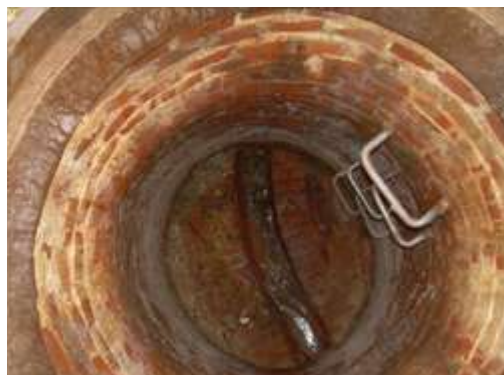
Top View

Bench and Channel debris.

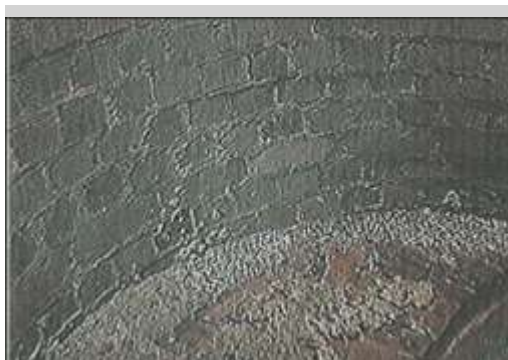
Defect

Barrel deterioration and infiltration. Bench debris

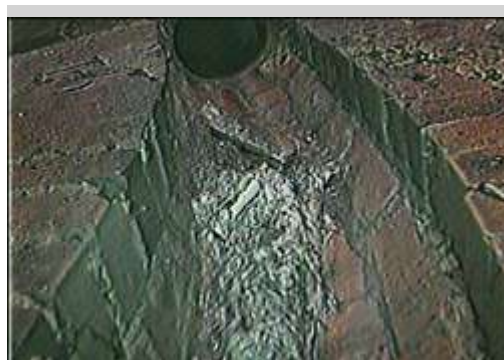
Defect

Channel deterioration and debris.

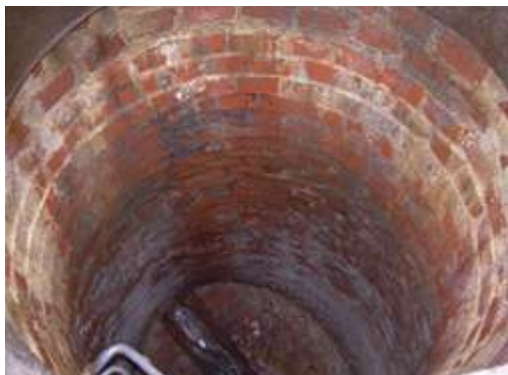
Defect

Frame leaks. Adjustment deterioration and infiltration. Corbel and Barrel infiltration - other side.

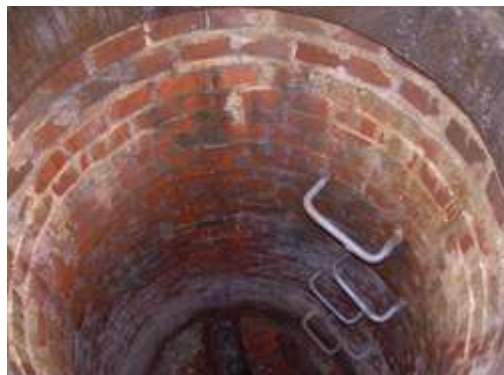
Defect

Frame leaks. Adjustment, Corbel and Barrel infiltration.

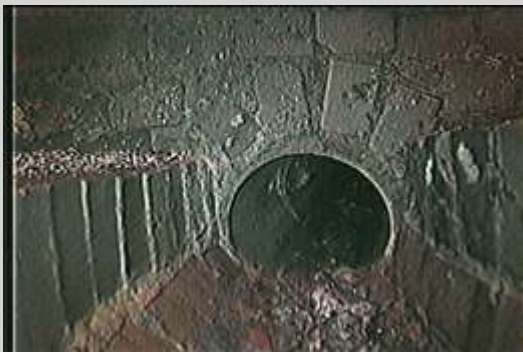
Pipe Out @ 12 O'Clock

Deposits: ☐ None ☒ **Mud** ☐ Sludge ☒ **Debris** ☒ **Grease**

Silt Depth: **0.5** (in.) Deposits Extent: **Light**
